INSTALLATION RESTORATION PROGRAM

REMEDIAL INVESTIGATION REPORT

FORBES FIELD AIR NATIONAL GUARD BASE
TOPEKA, KANSAS

OCTOBER 1989

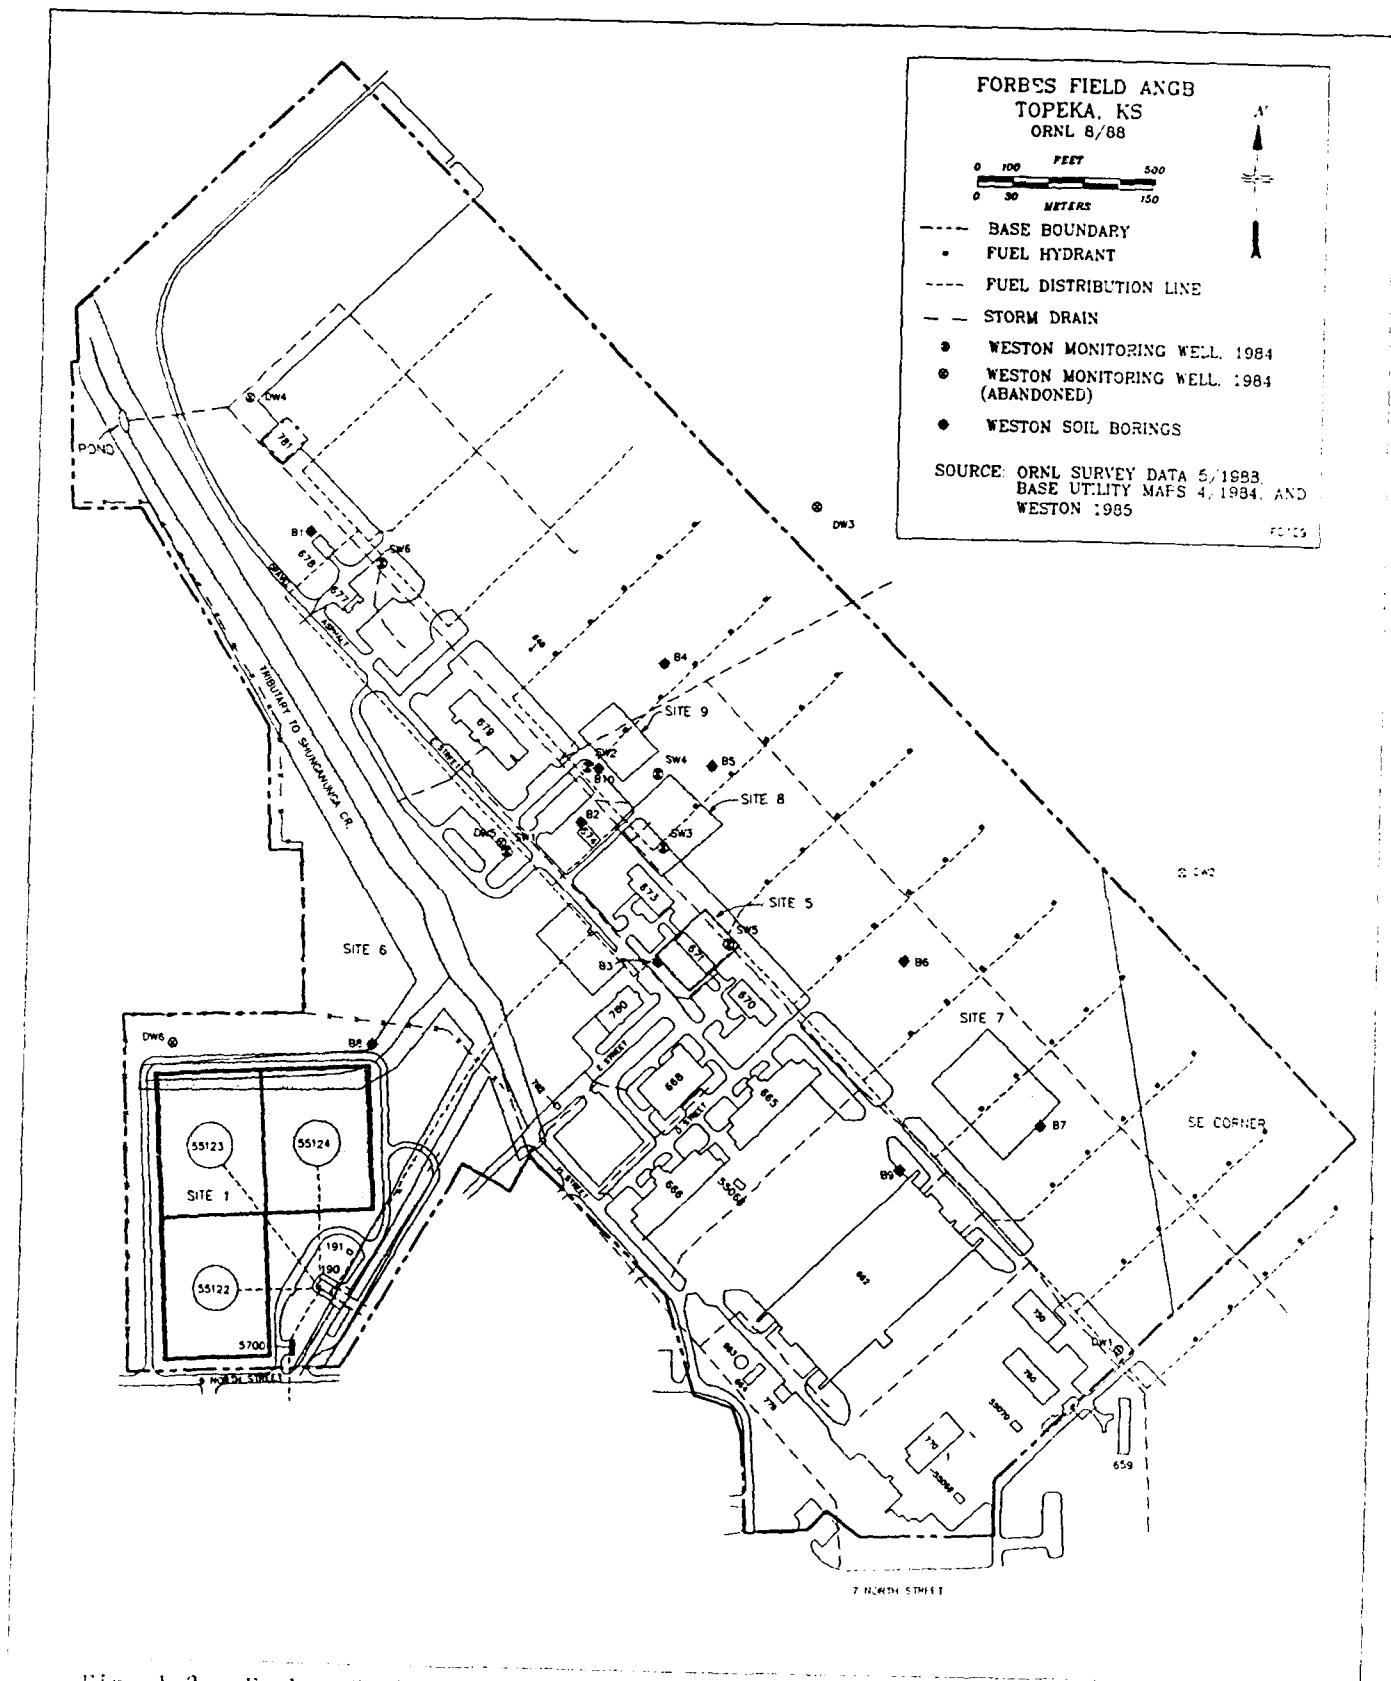
Fig. 1.2. Forbes Field ANGB, Weston monitoring wells and soil borings, shown in relation to present sites.

The Weston discovery of contamination upgradient of all identified sites suggested that contamination was entering the base from an off-base source. The HMTC identified this area as the "southeastern corner of Forbes Field ANGB property" and recommended that the area be studied. Although not a HARM rated site, the southeast corner will be referred to as a "site" throughout this report. Figure 1.2 shows the seven study sites.

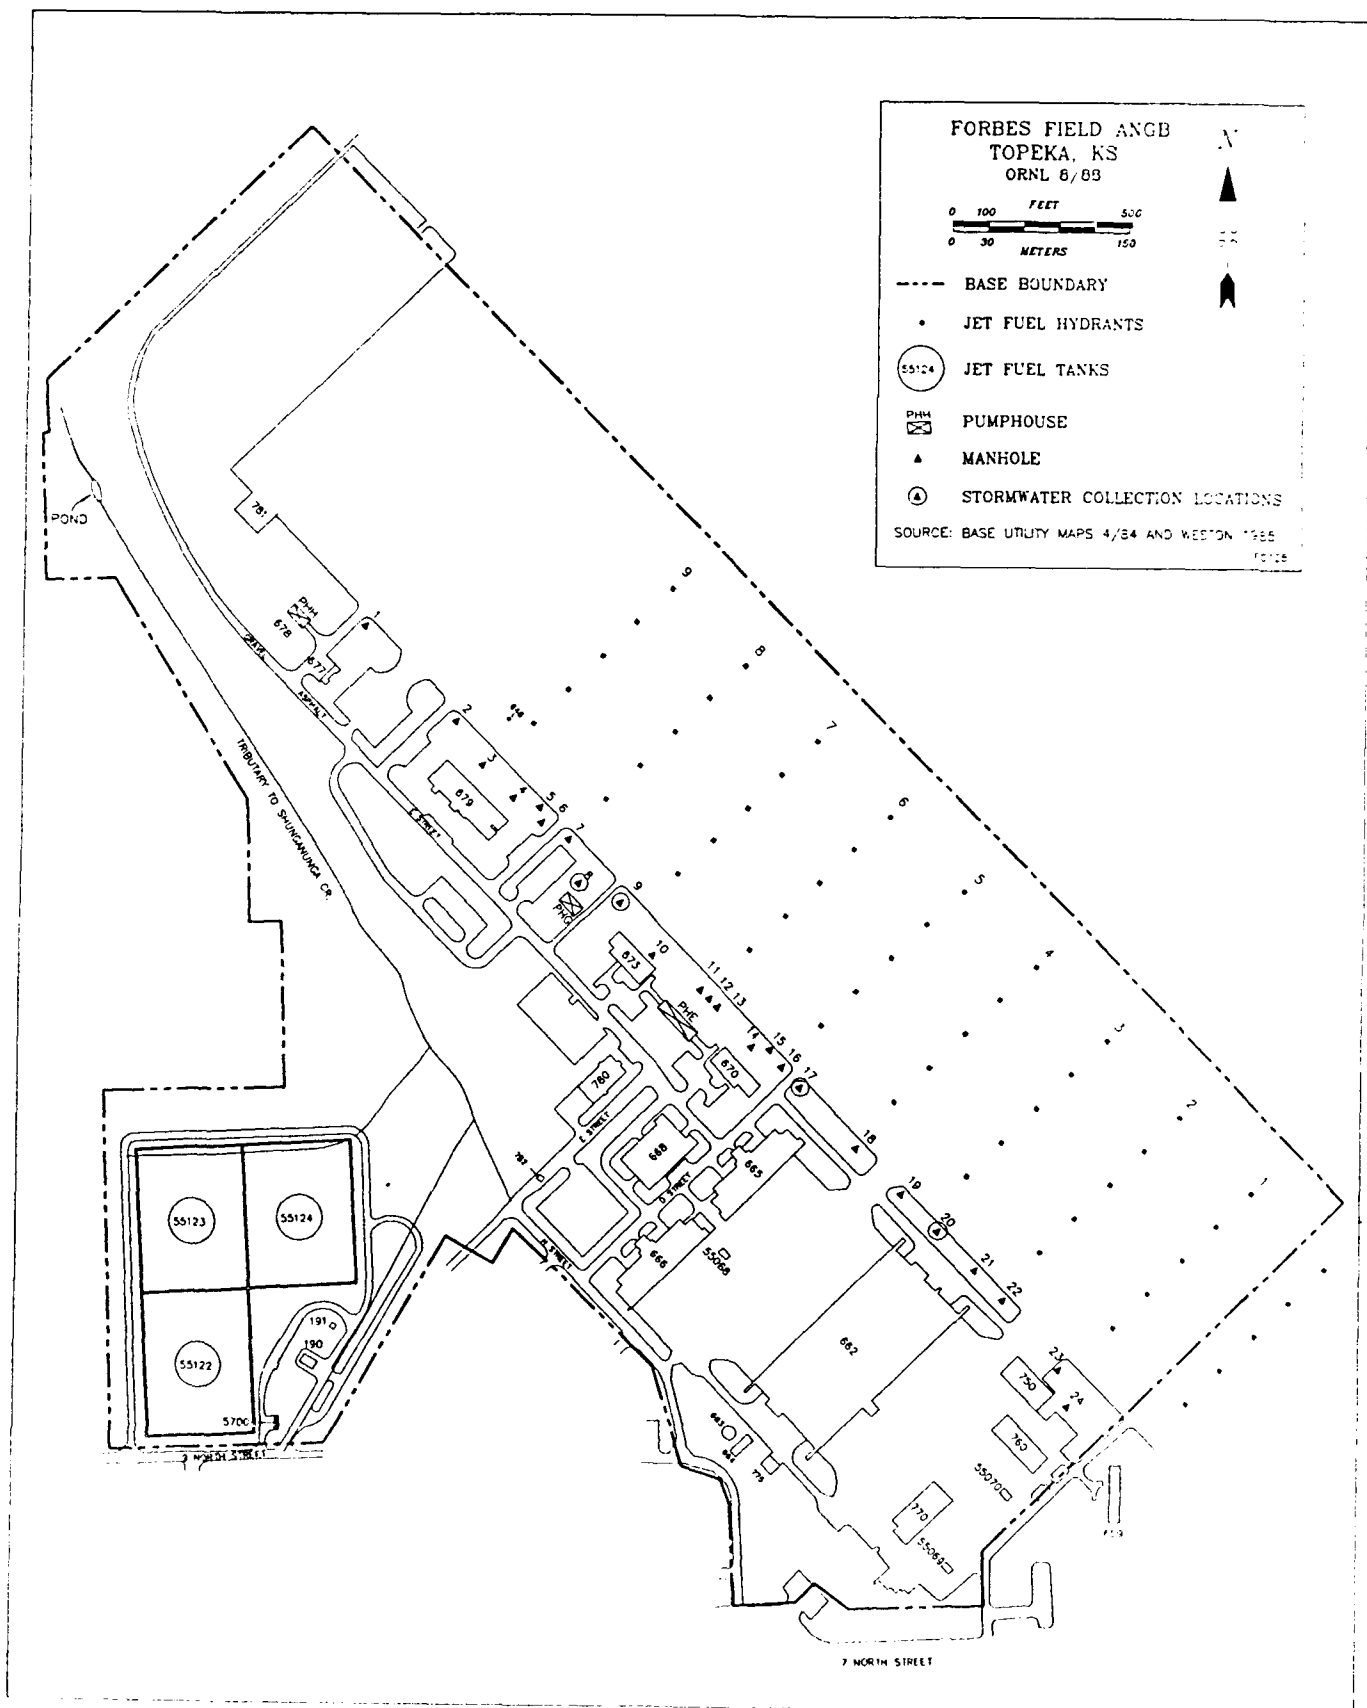
Fig. 1.3. Location of storm sewer manholes and storm water collection points.

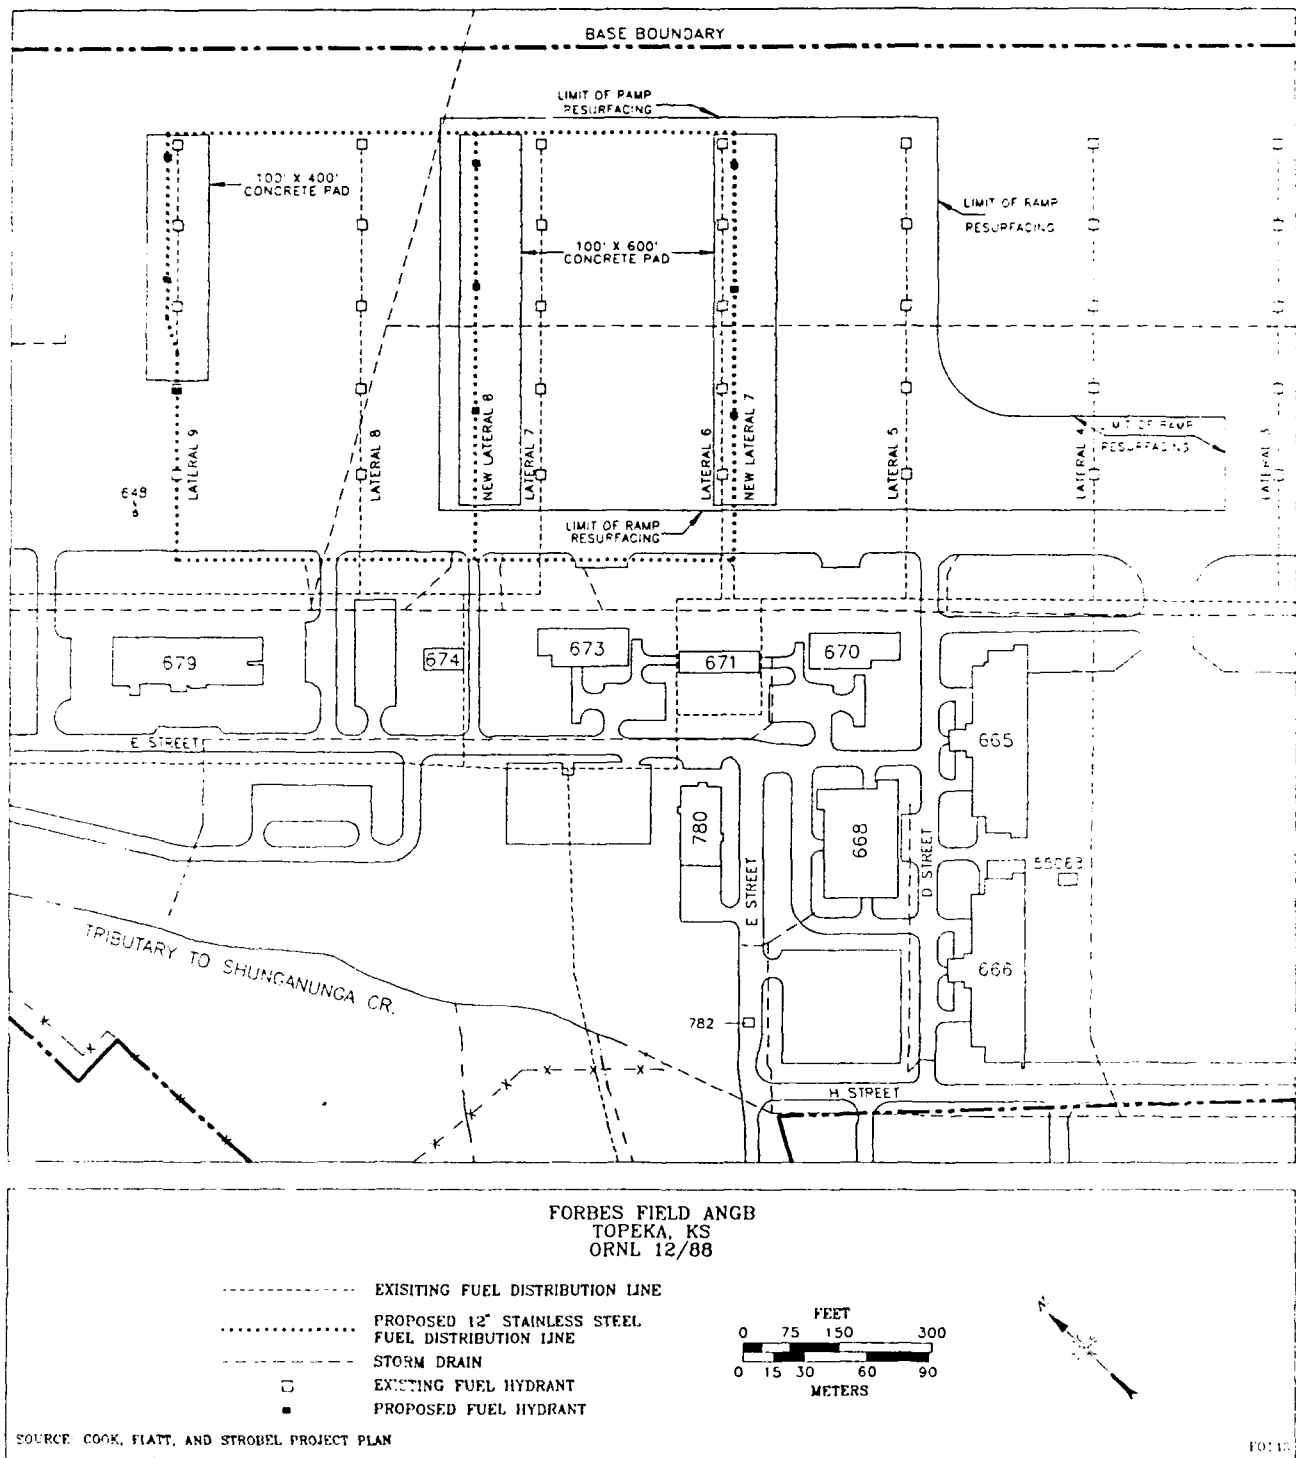
Fig. 1.4. Proposed ramp construction project.

The KSANG intends to modify a significant portion of the aircraft parking ramp in the near future (1989, if possible). Existing laterals 6, 7, and 8 (Fig. 1.4) will be abandoned. A new fuel lateral 7 will be installed south of the present lateral 6 and a new fuel lateral 8 will be installed between the existing fuel lateral 7 and 8. Fuel lateral 9 will be removed from the distribution line to the second fuel hydrant, and will be replaced with a new line. From the second hydrant toward the east, the old fuel line will be abandoned and replaced by a new section offset to the north.

A portion of the asphalt surface of the ramp from fuel lateral 8 to fuel lateral 4 will be removed and replaced. New concrete pads will be installed over the new fuel laterals.

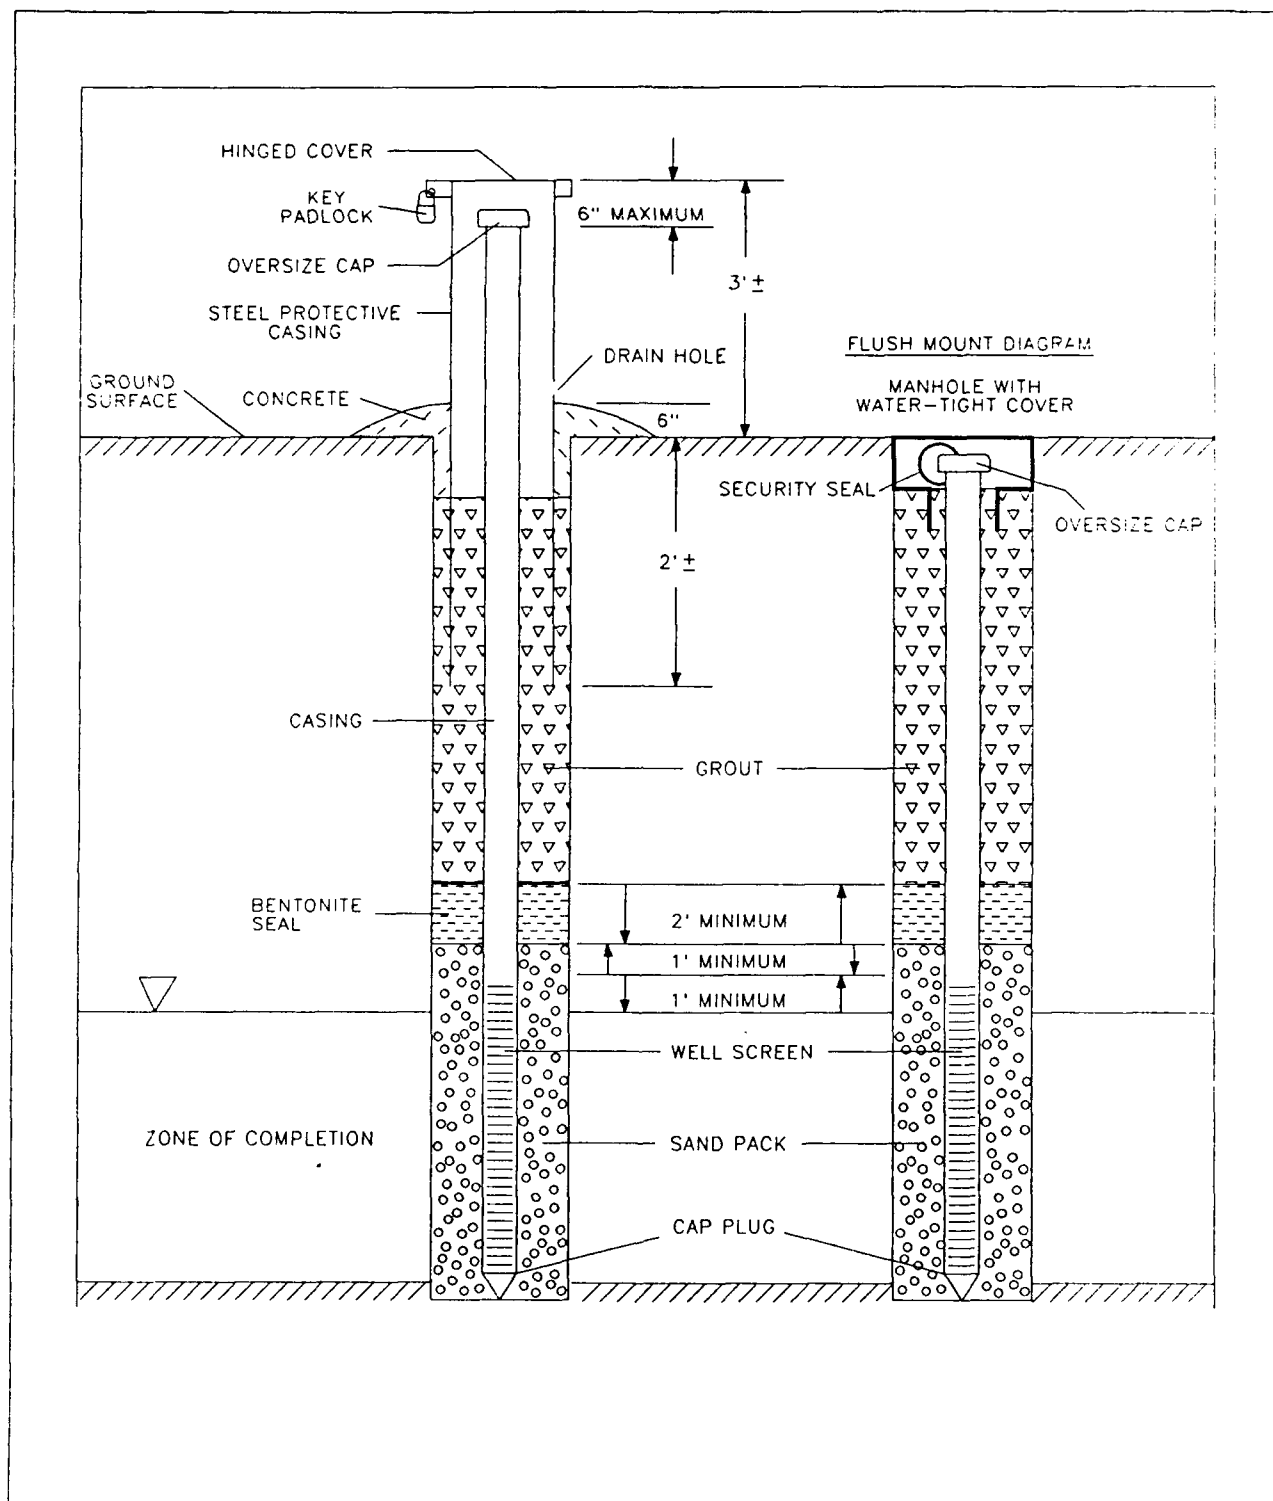
Fig. 2.1. Schematic diagram of monitoring well construction.

All wells finished above ground were protected with a 5-ft length of 6 in. diameter steel casing extending about 2.5 ft above ground and set in grout. Protective casing was secured by a padlocked outer protective cap. Additional protection was provided by three 3 in. diameter steel posts erected radially 2 ft from each well, installed 2 ft below ground surface and at least 3 ft above ground surface. A mortar collar extending 0.3 to 0.5 ft above ground surface was placed around the protective casing. The collar continued radially, sloping away from the protective casing approximately 3 ft, encompassing the steel posts. A 1/4 in. diameter hole (drainage port) was drilled through the protective casing above the mortar collar. For wells located in areas of aircraft or vehicle traffic, a watertight manhole assembly was installed. The manhole cover was set flush with the concrete to protect the wells and to prevent interference with daily activities. MW003, MW005, MW006, MW007, MW011, MW012, MW013, MW014, and MW023 required the flush mount installation.

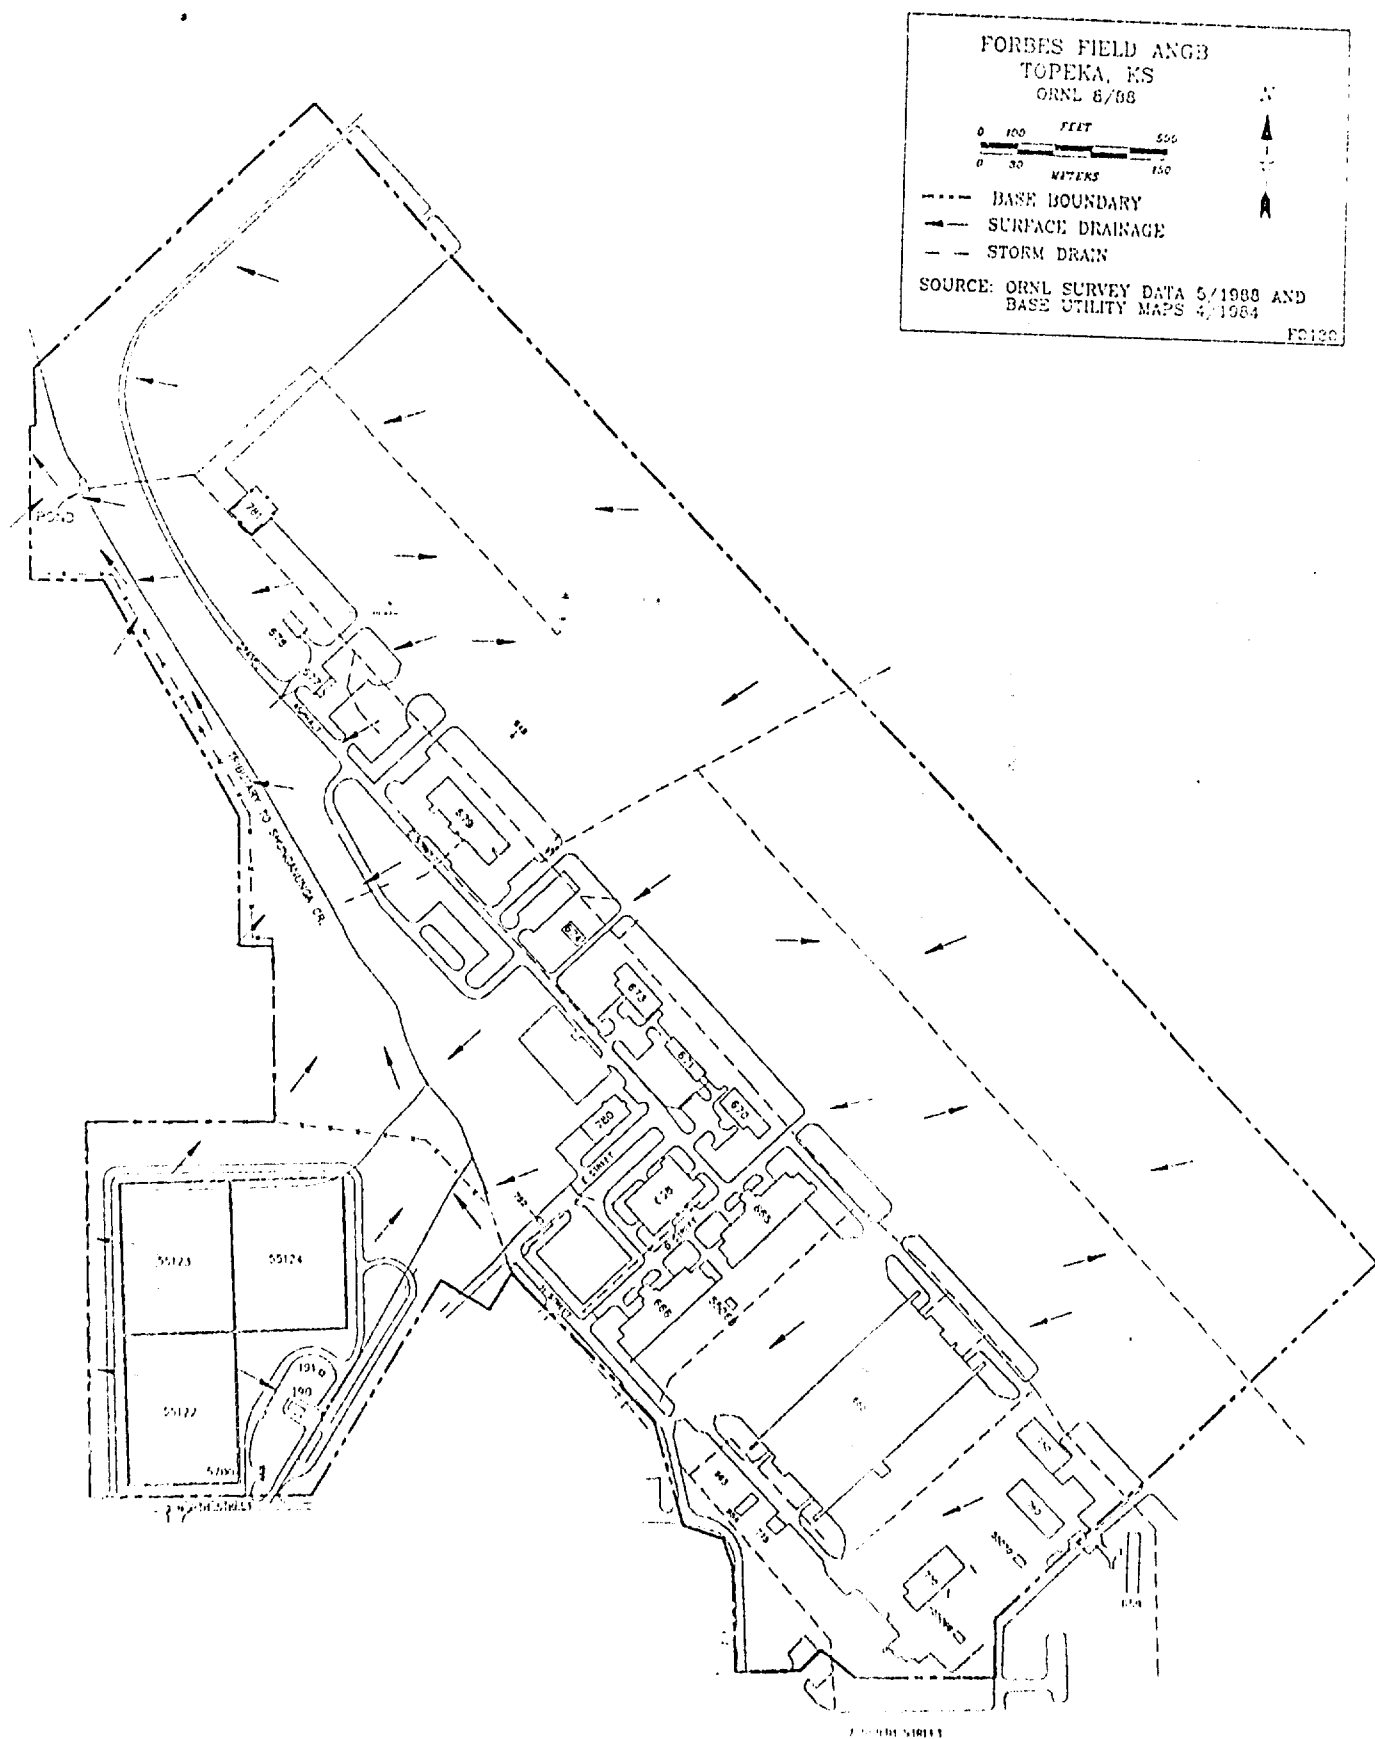
Fig. 2.1. Surface runoff patterns at Forbes Field ANG3.
2-24

Surface runoff at Forbes Field ANGB occurs dominantly as sheet flow, due to the relatively flat topography, and either directly discharges to the unnamed tributary or is routed through the storm sewer and then eventually into the creek. Figure 2.3 shows surface runoff patterns for the base.

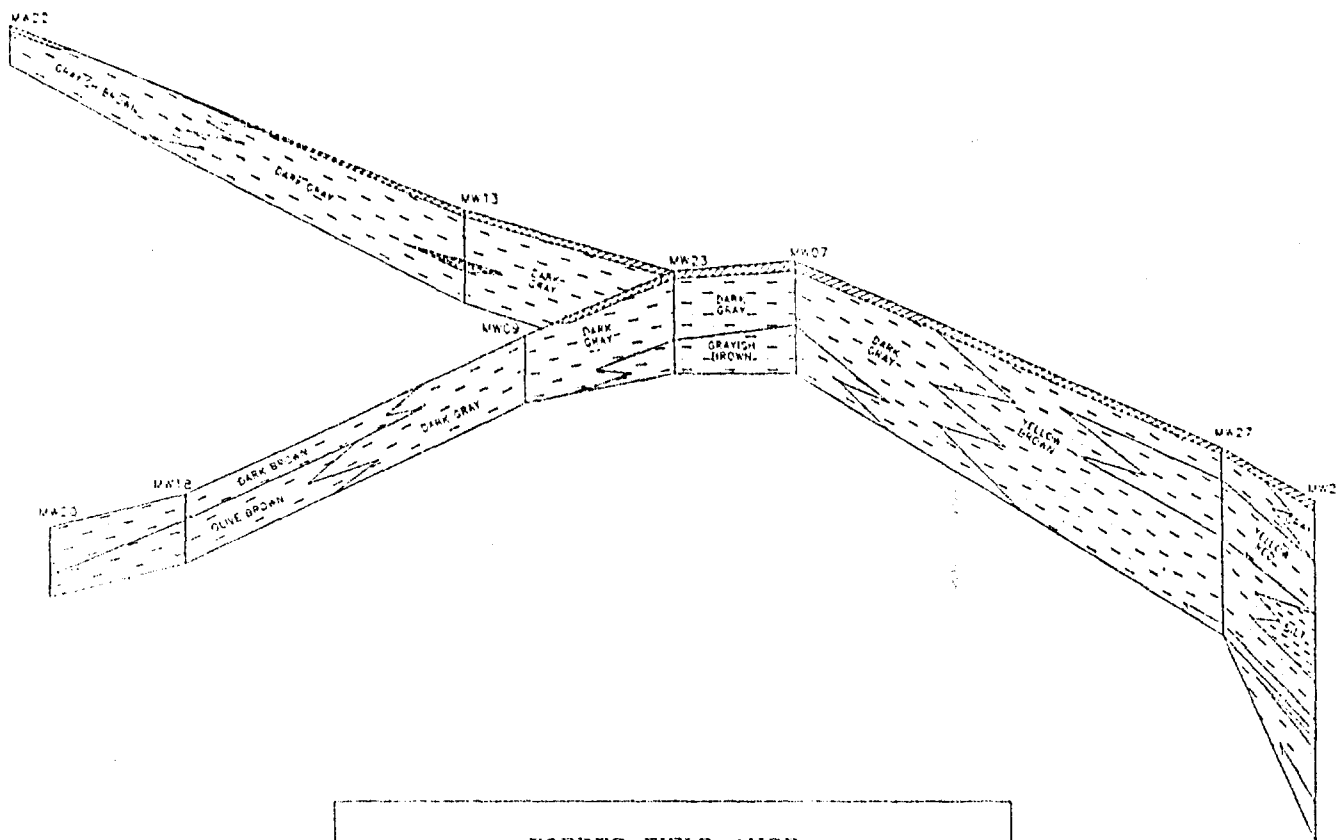
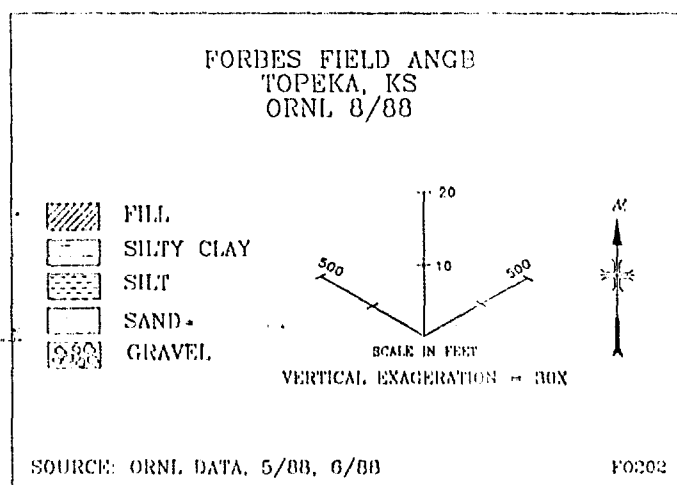
Fig. 2.5. Fence diagram of surface deposits.

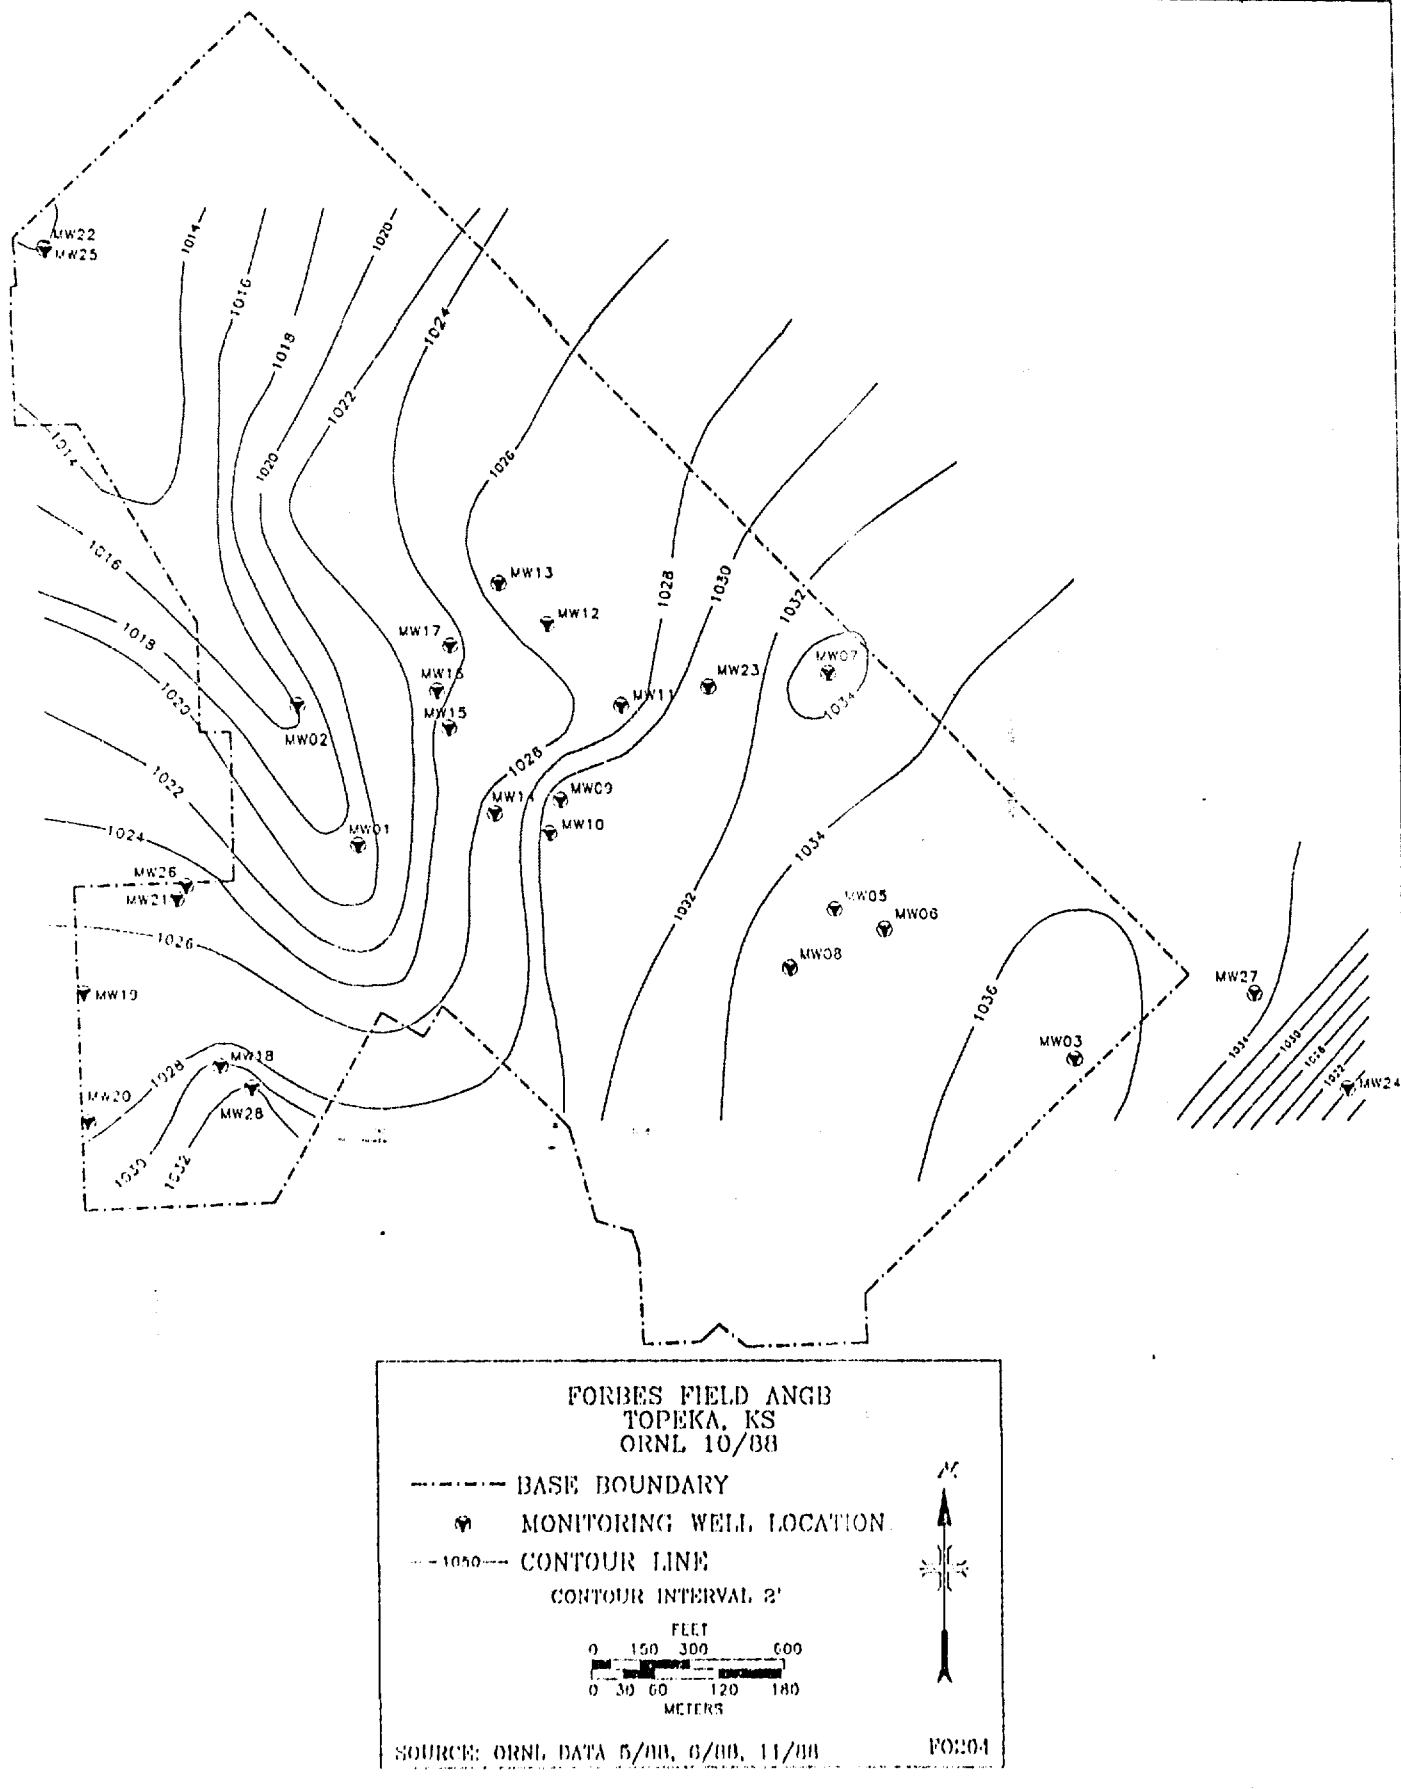
Fig. 2.6. Contour map of weathered bedrock surface.

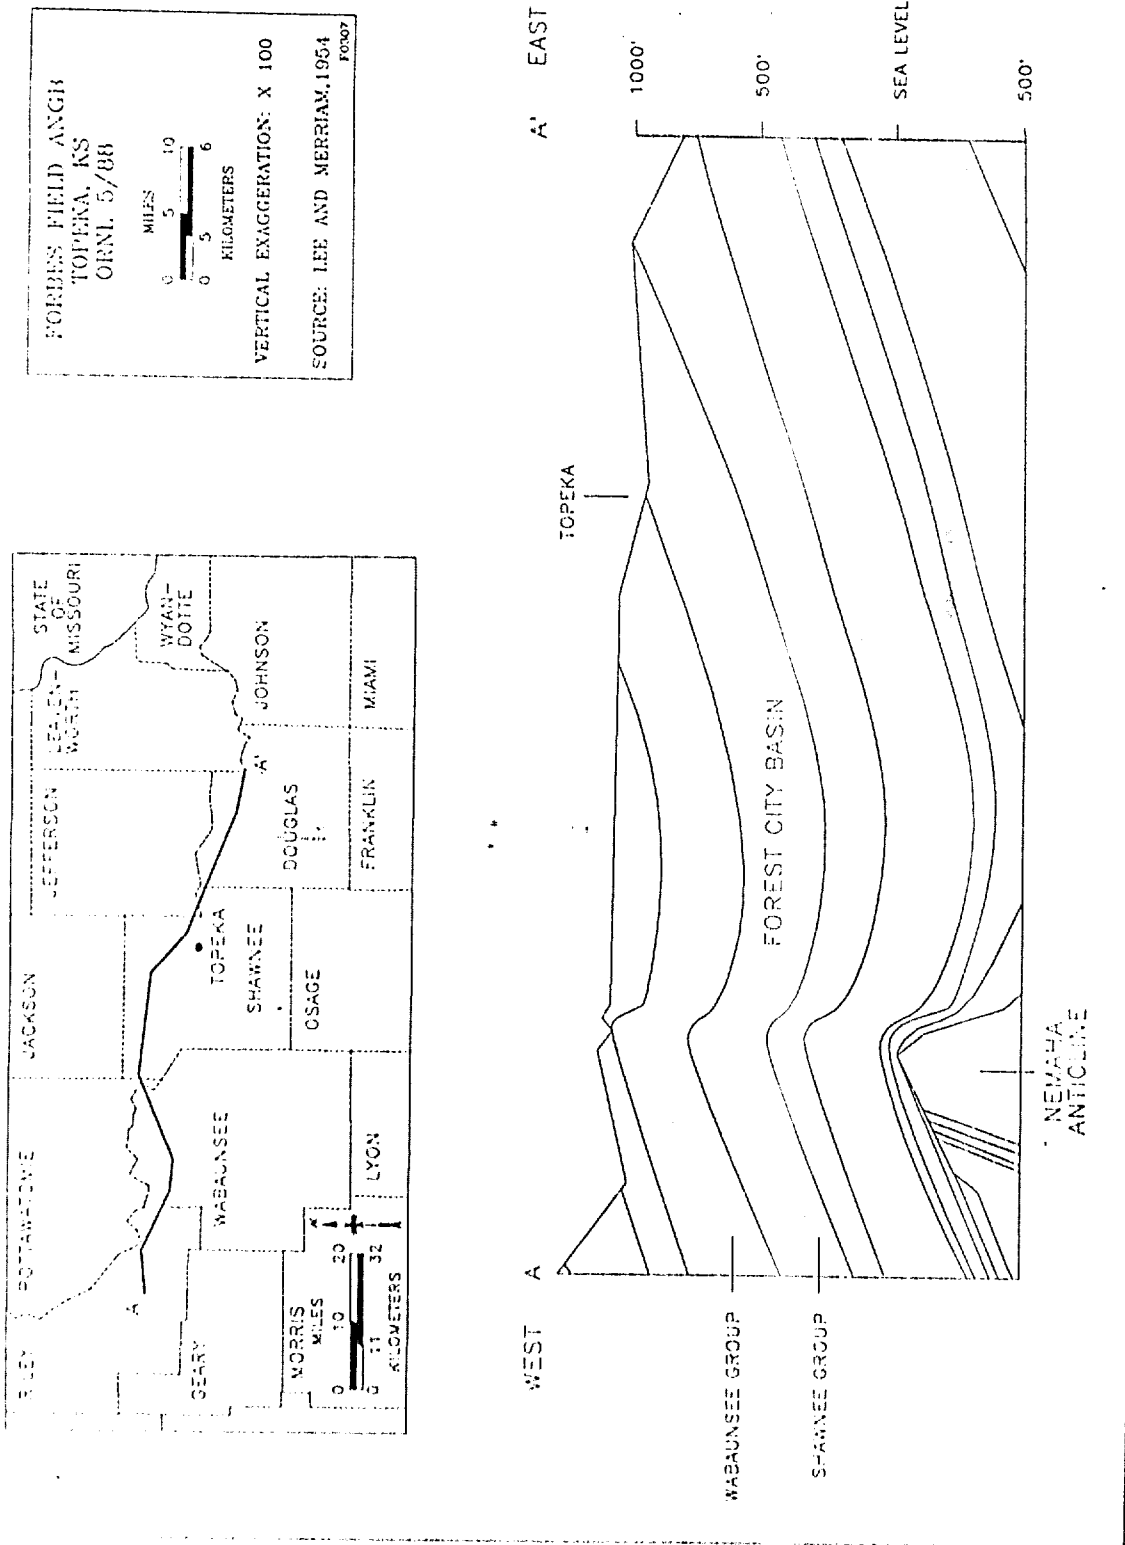
Fig. 2.7. Regional cross section of northeastern Kansas.

The geology at Forbes Field ANGB is dominated by two major geologic groups: the Pennsylvanian Wabaunsee and Shawnee Groups (Fig. 2.7, 2.8a, and 2.8b). The formations within these groups exhibit the transgressive-regressive sedimentation characteristic of cyclothems in which largely nonmarine sandy shales with coals alternate with sandstones, marine shales, and limestones (Heckel 1978). Of the Wabaunsee Group, the Howard Limestone and Severy Shale formations were encountered in the three coreholes. In descending order, the Howard Limestone consists of the Utopia Limestone, the Winzeler Shale, the Church Limestone, and the Aarde Shale members. The Severy Shale formation underlies the Howard Limestone. The Shawnee group is

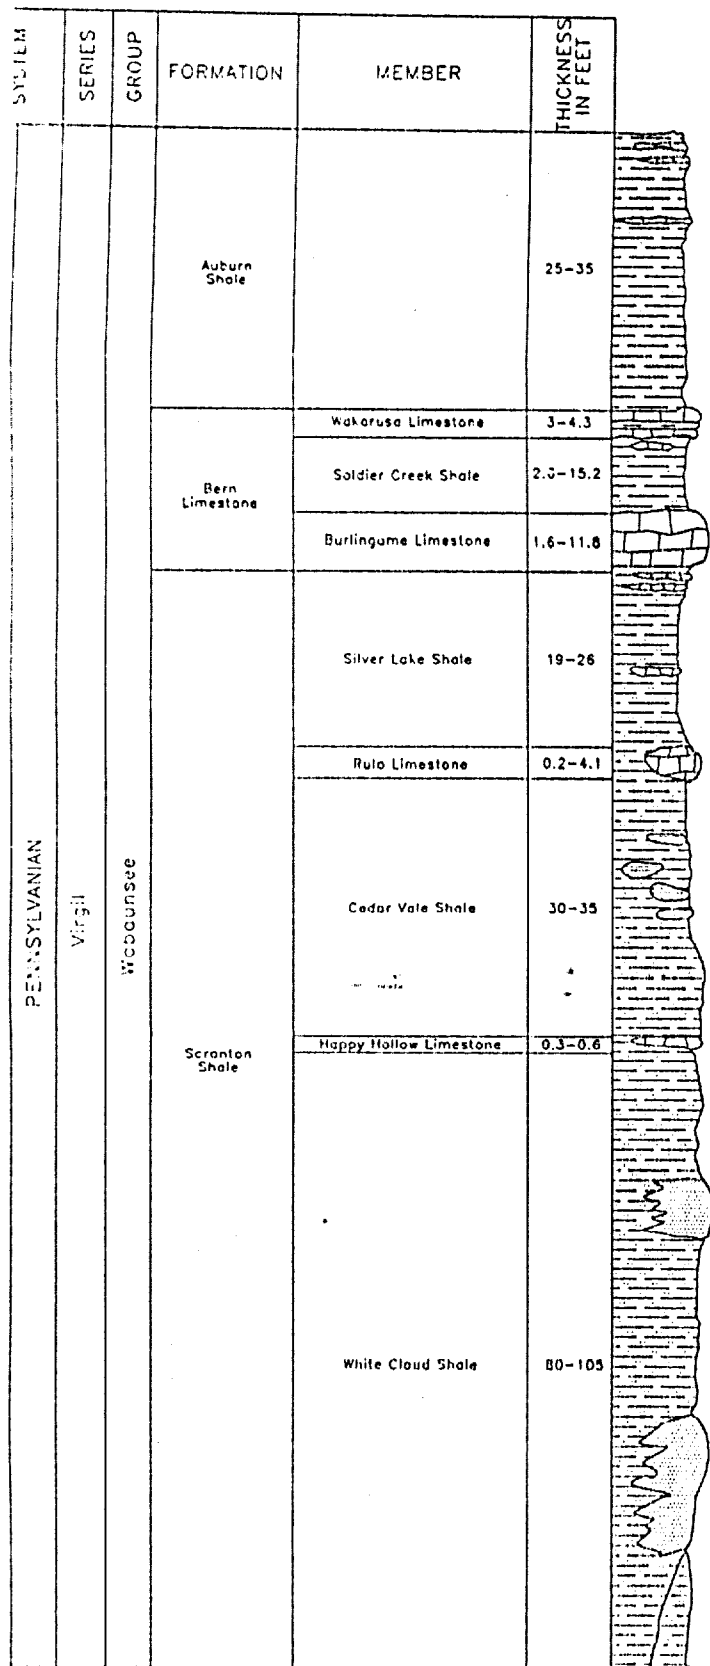
Fig. 2.8a. Stratigraphic section of Forbes Field ANGB vicinity.
2-34

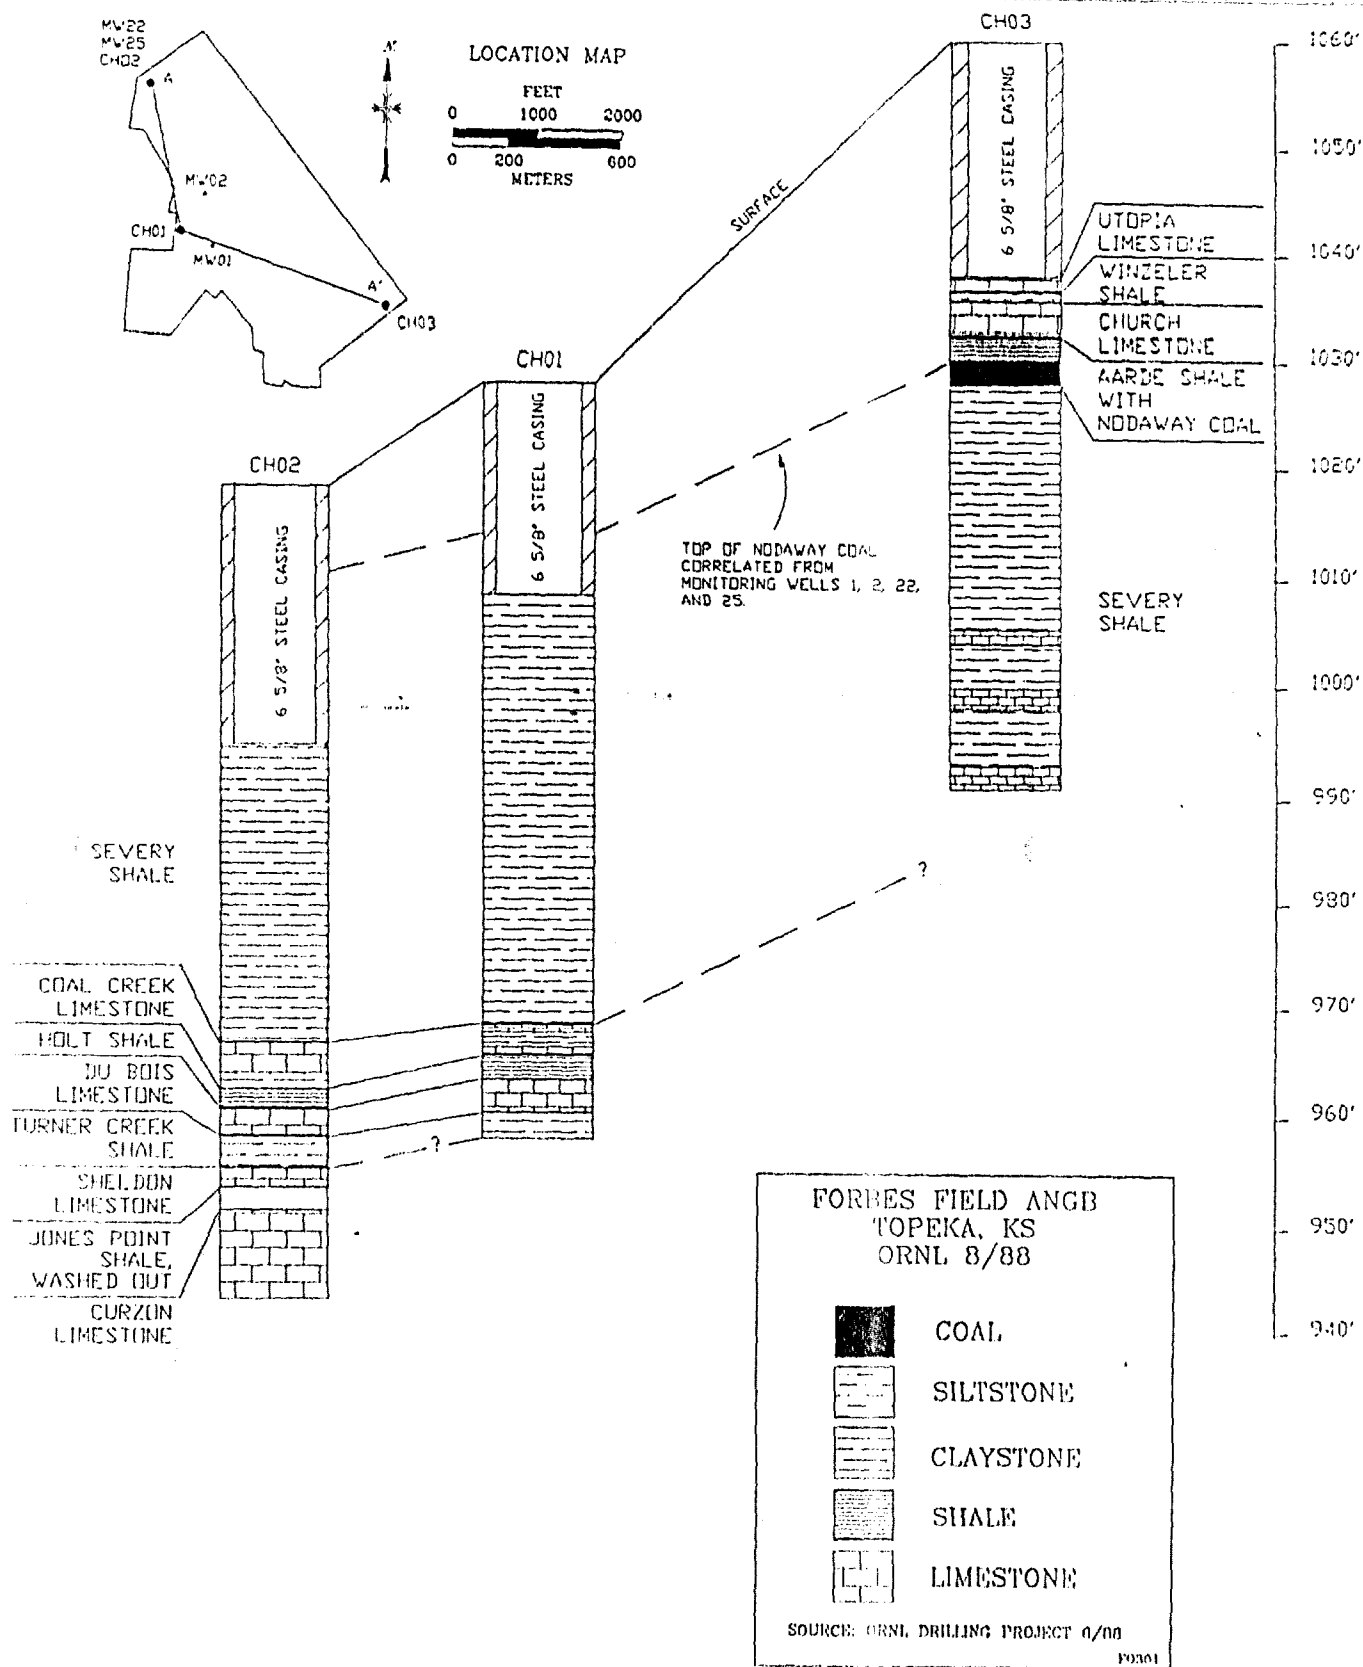
Fig. 2.9. Correlation diagram of bedrock wells.
